## **Addendum # 1 Housing Rehabilitation – Berlin #6 REBID**

**Berlin # 6 – November 28, 2022**

RE: 8516 Foreman Rd Berlin, MD

# Wood Destroying Insect Inspection Report

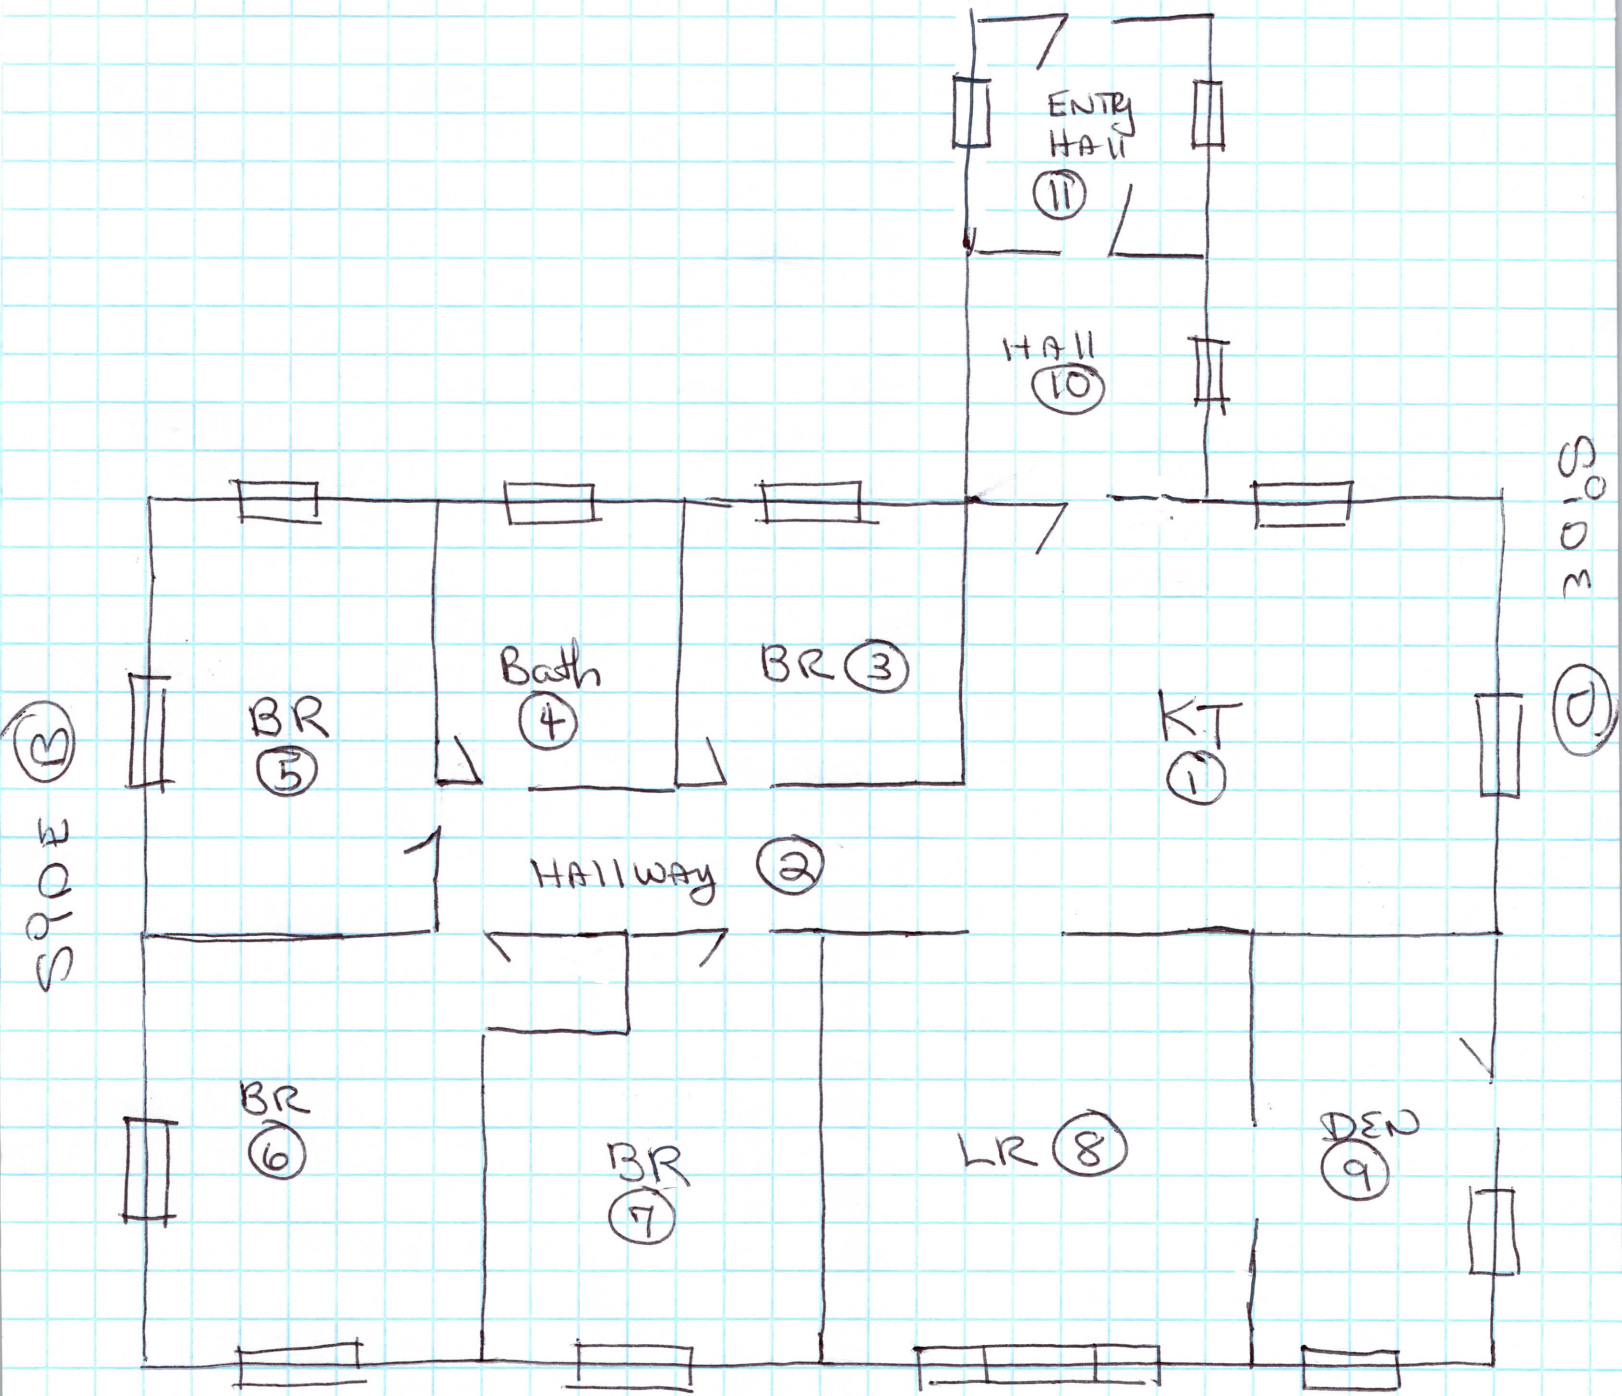
The risk assessment determined that there is lead-based paint and lead hazards present in the property as of the date of the assessment. See enclosed floor plan, xrf readings and attached pictures.

Kitchen (#1)	Ceiling		white	Positive
	Window Sash	Side C	white	Positive
	Window Sill	Side C	white	Positive
Hall (#10)	Door, Door Jamb	Side A	white	Positive
	Door Casing	Side A	white	Positive
	Closet Dr, Casing	Side B	white	Positive
