2025 ANNUAL AND UNDERWATER BRIDGE INSPECTION REPORT

August 6, 2025

BRIDGE NO. WO0202001
BAYSIDE ROAD
OVER
TANHOUSE CREEK

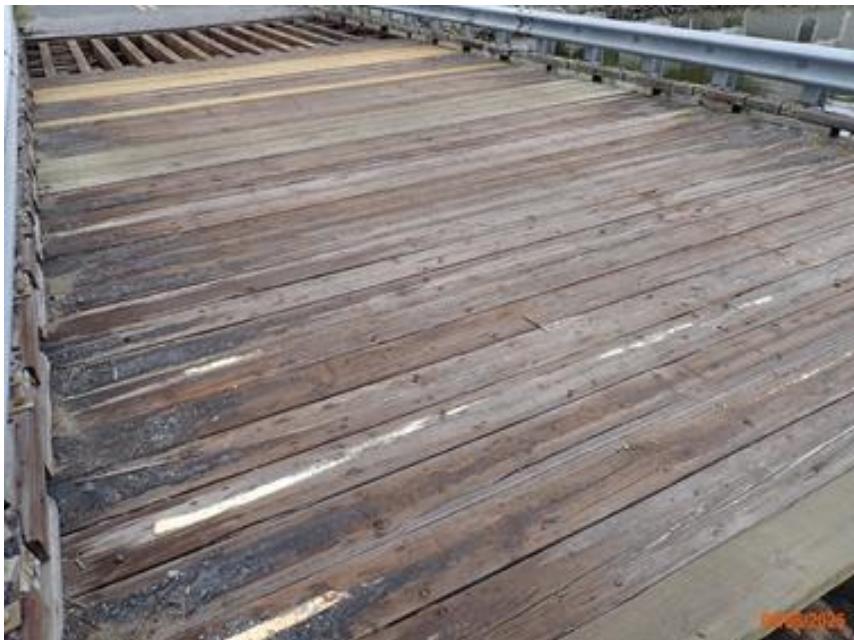
Photo 7

The deck is in fair condition (Photo 7).

Typical deck, looking northeast.

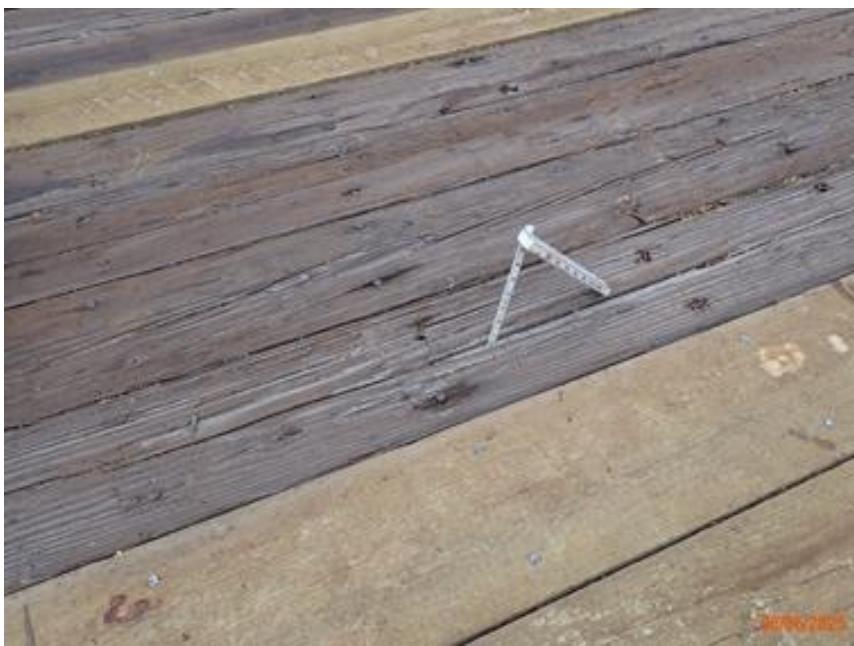
Photo 8

Typical checks, splintering, and weathering in the deck planks (Planks 27 through 29 in the Northbound Lane shown, looking southwest).

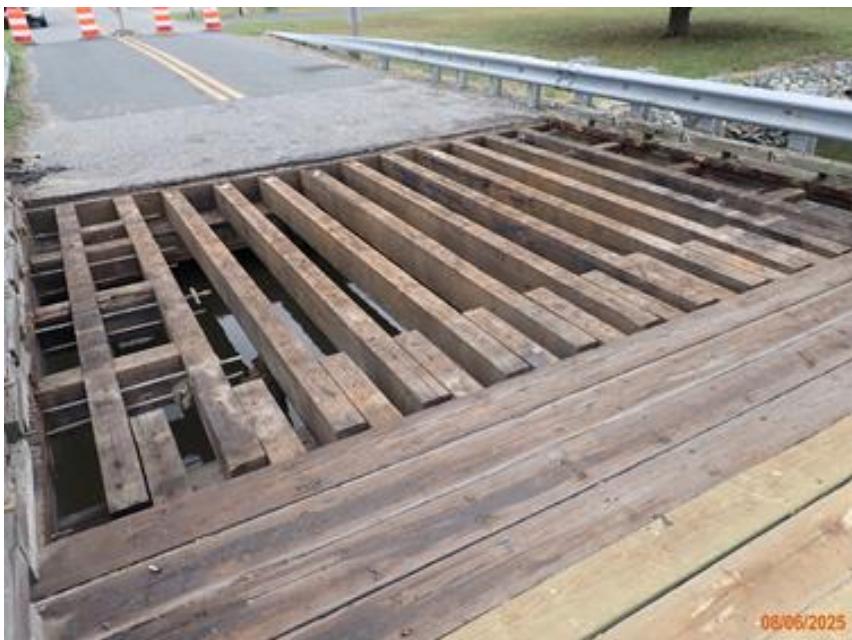
Photo 9

Planks 1 through 18, and 60 (at the South Abutment) have been removed as part of the deck repairs (Photo 9). Planks 23 through 26, 31, and 59 have been replaced as part of the deck repairs (Photo 10).

Planks 1 through 18 removed during deck repairs, looking northeast.

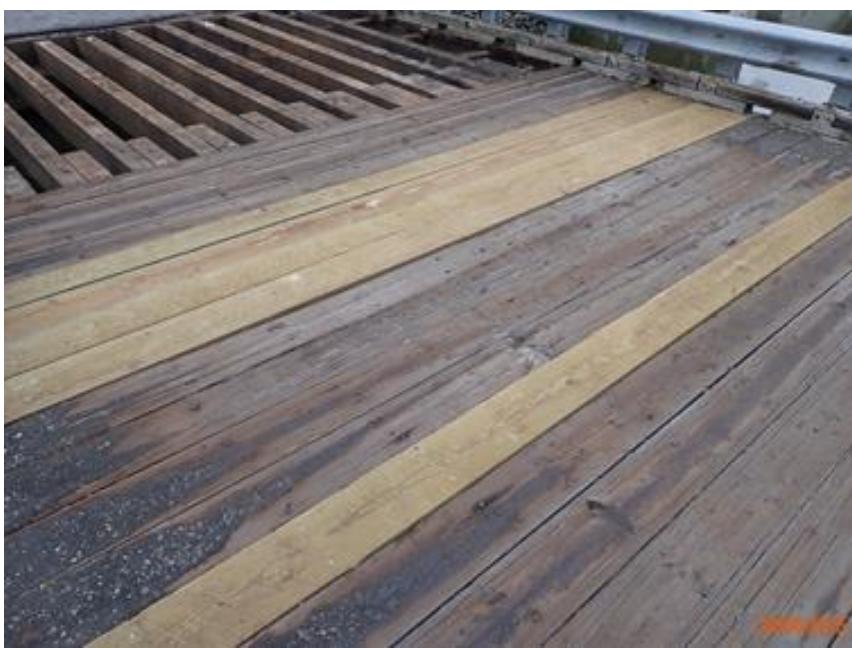
Photo 10

Planks 23 through 26 and 31 replaced in the deck, looking northeast.

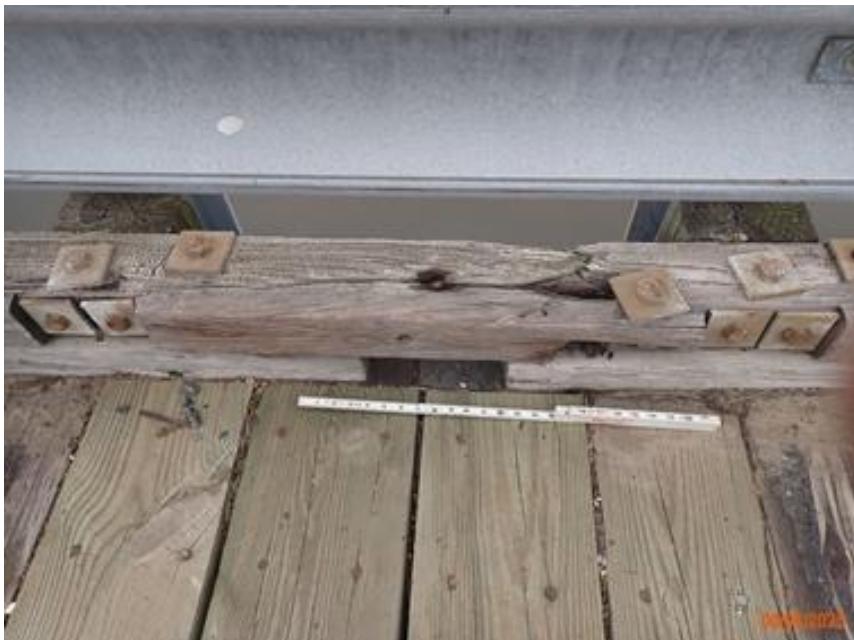
Photo 11

2. The timber curbs exhibit splits, splintering, checks (up to 1/8" wide), and up to 1/2" deep pick penetrations scattered throughout. The curbs exhibit splits at several hardware connections, some of which expose bolt shafts. There are numerous curb to riser connection bolts missing. The East Curb exhibits an 11" long x full-height (4") x 2" deep splinter between Posts 8 and 9. There is a 3'-0" long area of splintering and decay in the south end of the West Curb and north end of the East Curb. Between Posts 9 and 10, the West Curb exhibits a split (2'-8" long x full-depth x 1/4" wide) with an associated full width transverse fracture and an exposed connection bolt a Post 9 (Photo 11).

Split with an associated transverse fracture in the West Curb between Posts 9 and 10, looking west.

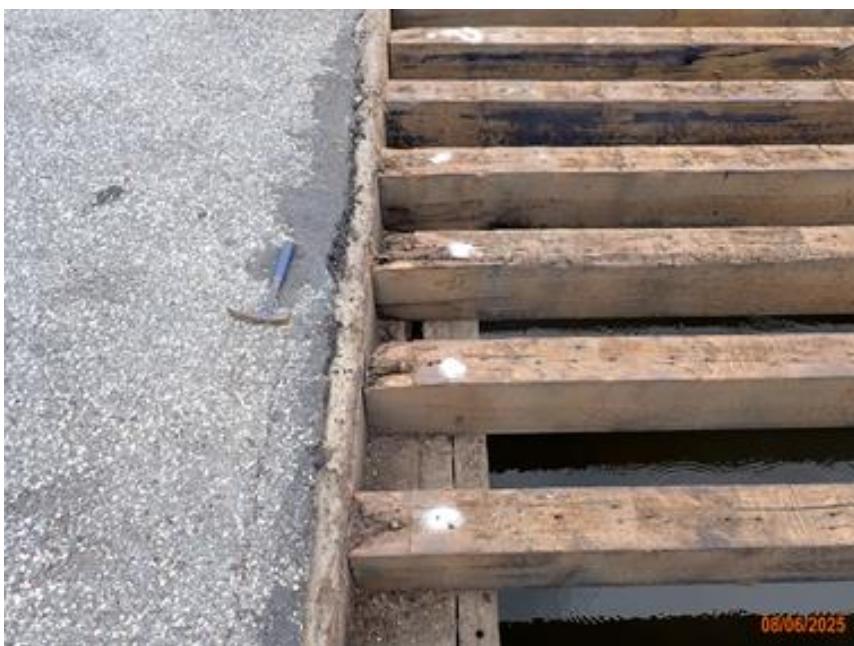
Photo 12

Span 1: At the North Abutment, Beams 4 through 8, and 10 exhibit severe rot (up to 1'-6" long x full-height x full-width) with section loss (up to 2" deep) in the top and north face (Photo 12). Beams 5 through 7 and 10 exhibit evidence of crushing with bulging and horizontal checks/splinters (up to 2'-0" long) in the vertical faces at the locations of severe rot at the North Abutment (Photo 13 and 14). There is a full-length x up to 1/4" wide check with up to 1" pick penetration in the west face of Beam 13 (Photo 15). At Pier 1, Beams 4 and 5, and 8 through 10 exhibit severe rot (up to 2'-0" long x full-width) with up to 3/4" deep pick penetration in the top face.

Severe rot with section loss in Beams 5 through 10 in Span 1 at the North Abutment, looking east.

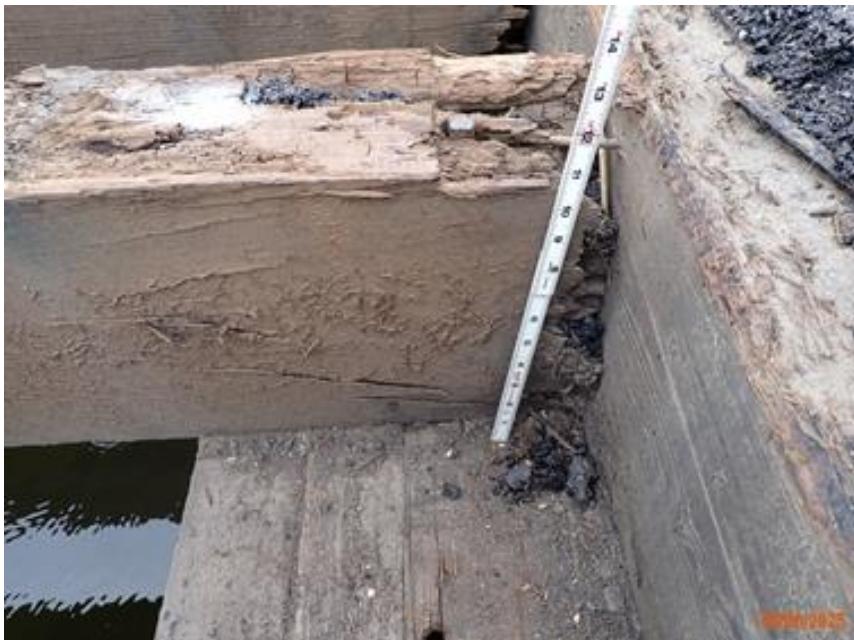
Photo 13

Rot, splinters, and section loss in the east face of Beam 7 in Span 1, at the North Abutment, looking west.

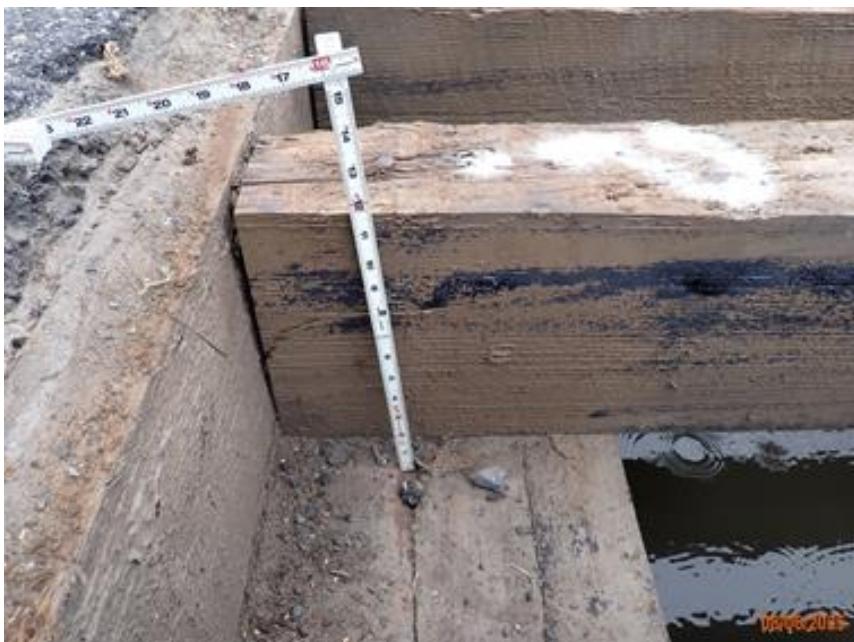
Photo 14

Evidence of crushing in the west face of Beam 10 in Span 1, at the North Abutment, looking east.

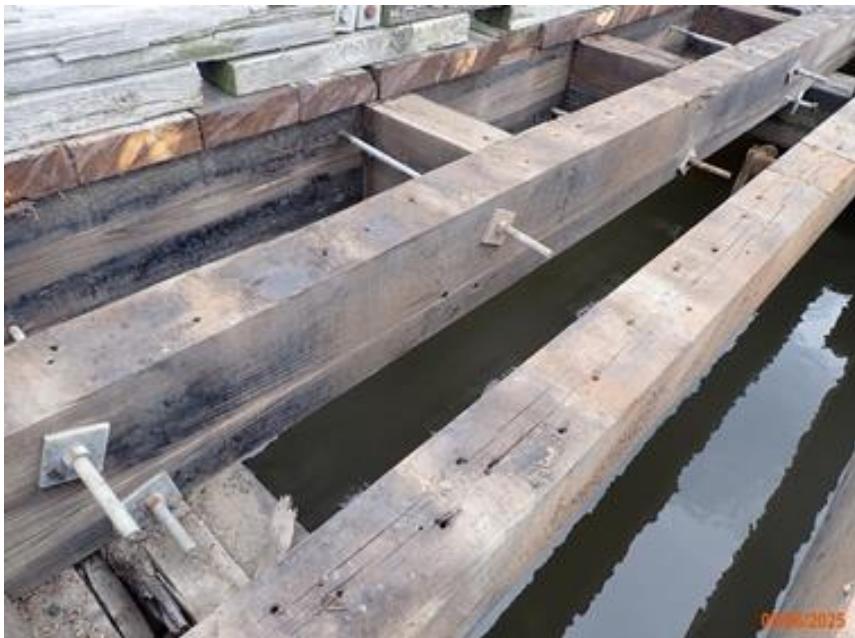
Photo 15

Full length check in the west face of Beam 13 in Span 1, looking southeast.

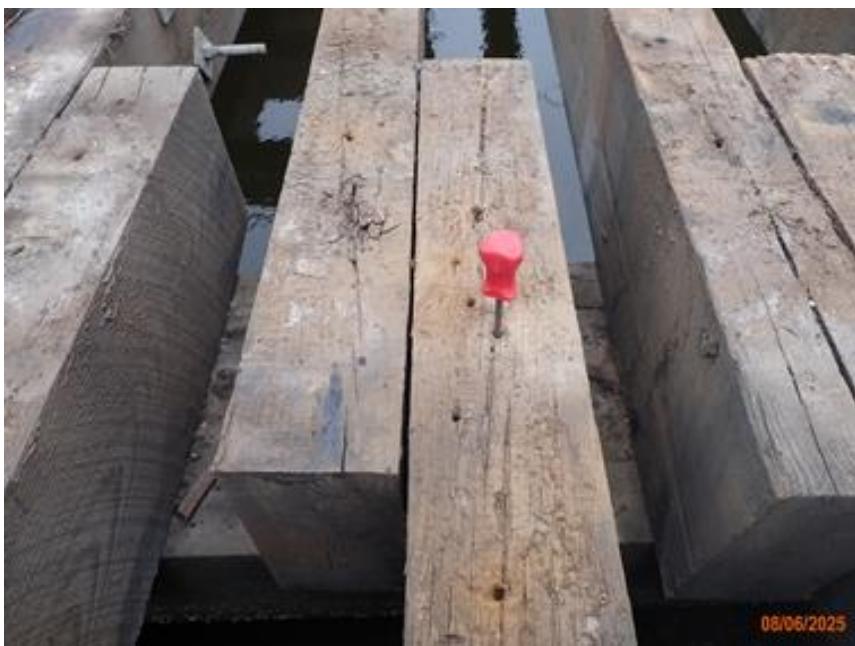
Photo 16

Span 2: At Pier 1, Beams 4 through 7 exhibit severe rot (up to 2'-0" long x full-width) with up to 1 3/4" deep pick penetrations in the top face (Photo 16).

Typical severe rot in the top face of Beams 4 through 7 in Span 2, at Bent 1 (Beam 4 shown, looking north).

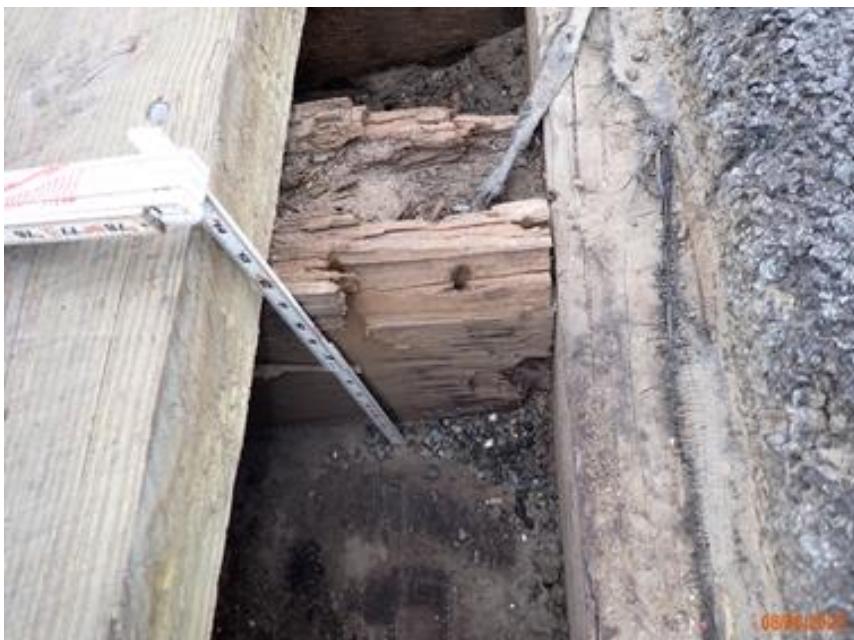
Photo 17

Span 4: At Pier 3, Beams 2 through 13 exhibit moderate rot with up to 1/2" deep pick penetration in the top face. At the South Abutment, Beams 4 through 11 exhibit severe rot (up to 1'-0" long x full-height x full-width) with section loss (up to 2" deep) in the top and north faces (Photo 17). Beams 4 and 9 exhibit evidence of crushing (potential failure) with bulging and horizontal checks/splinters (up to 1'-6" long) in the vertical faces at the locations of severe rot at the South Abutment.

Typical severe rot with section loss in the end of Beams 4 through 11 in Span 4 at the South Abutment (Beam 5 shown, looking east).

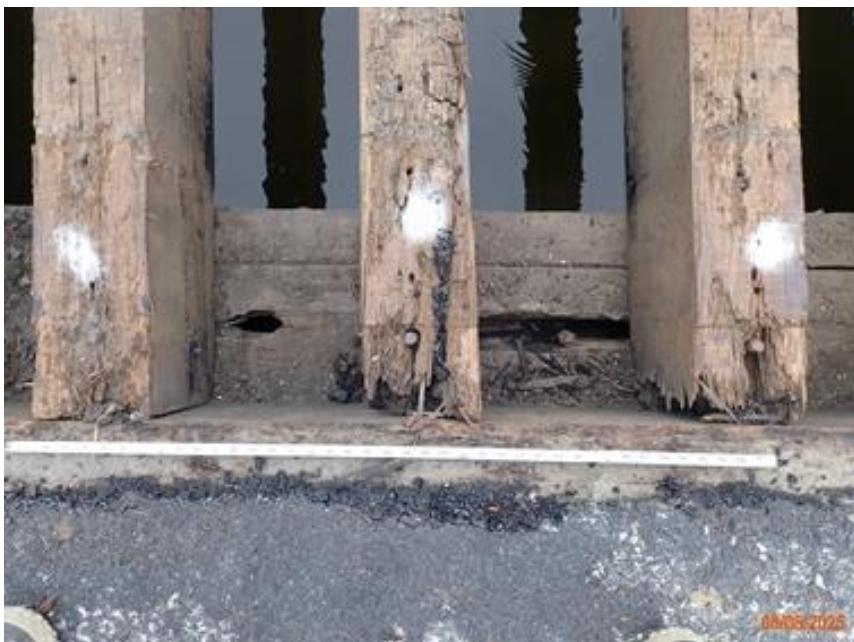
Photo 19

Severe rot with full depth holes in the North Abutment Bent Cap between Beams 6 and 8, looking south.

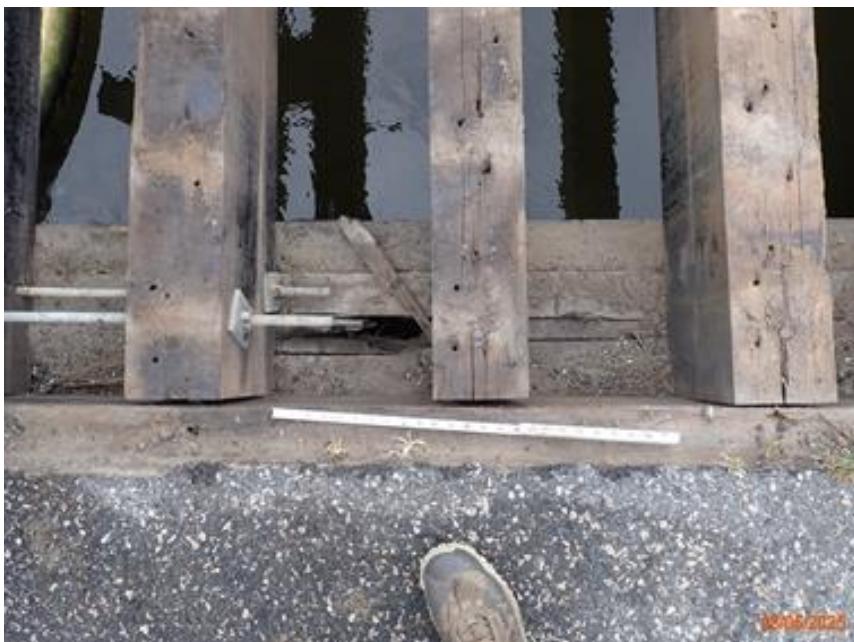
Photo 20

Severe rot with full depth holes in the North Abutment Bent Cap between Beams 11 and 13, looking south.

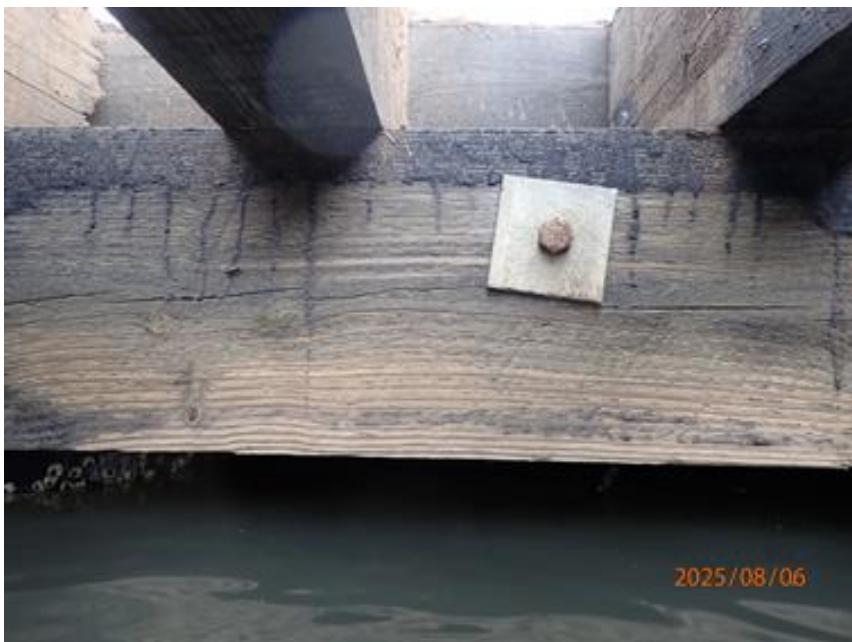
Photo 21

Area of checks in the north face of the South Abutment Bent Cap (timber plate) at Pile 3, looking south.

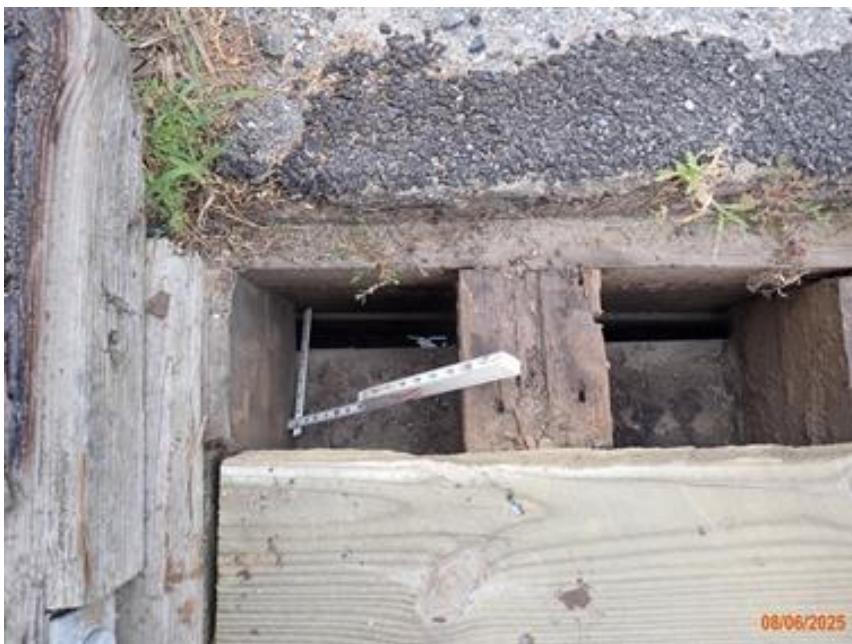
Photo 22

Gap between the east end of the South Abutment Bent Cap and backwall due to movement (north), looking south.

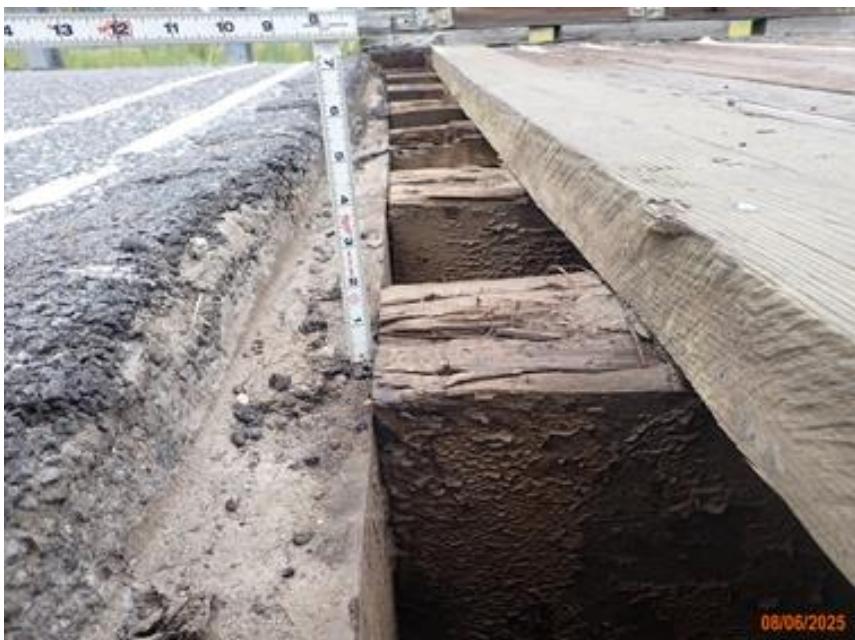
Photo 23

South Abutment: The pile cap exhibits minor checks (up to 1/16" wide) scattered throughout. The cap exhibits hollow-sounding areas (full-height x full-width) with surface rot throughout and up to 1/2" deep pick penetrations in the top face. The north face of the cap (timber plate) exhibits an area of checks (up to 3'-0" long) below the hardware at Pile 3 (Photo 21). The cap exhibits evidence of movement (north) with a gap between the cap and the backwall that is 7/8" wide at the west end and up to 3 3/8" wide at the east end (Photo 22). There is a vertical differential (1/2") between the top of the beams and the backwall (beams higher) along the length of the abutment (Photo 23).

Vertical offset of the beams and the backwall at the South Abutment, looking west.

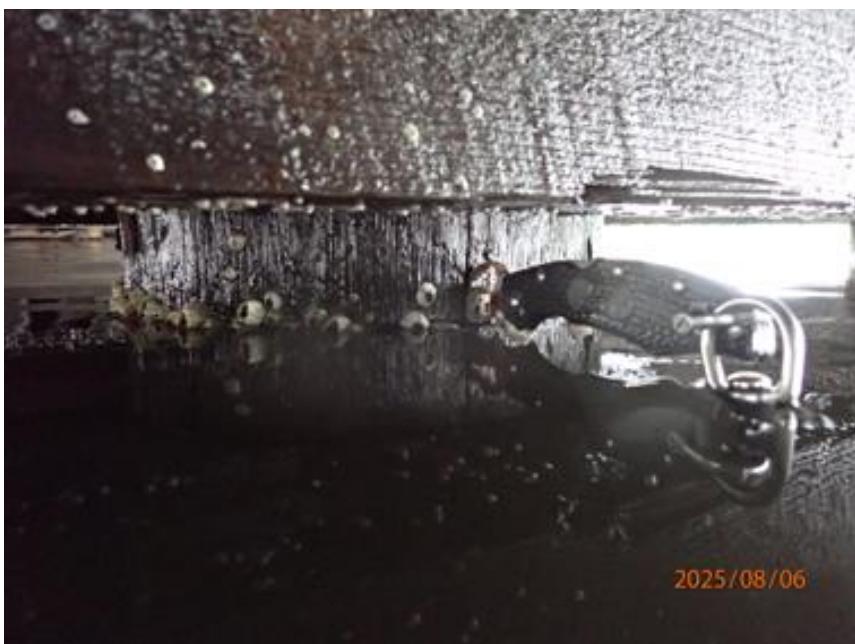
Photo 24

2. The timber piles exhibit up to 1/8" wide checks and hollow-sounding scattered areas throughout (Photo 24). There are typical pick penetrations of 1/4" deep and up to 1/2" marine growth. The hardware on the piles exhibits severe corrosion with up to 30% section loss. There are a few, up to 1/16" to 1/8" wide, gaps between the piles and caps at the piers, resulting in up to 30% loss of bearing. There are old piles present in Spans 1 and 4.

Typical check in the timber piles (Pile 1 at Bent 2 shown, looking north).

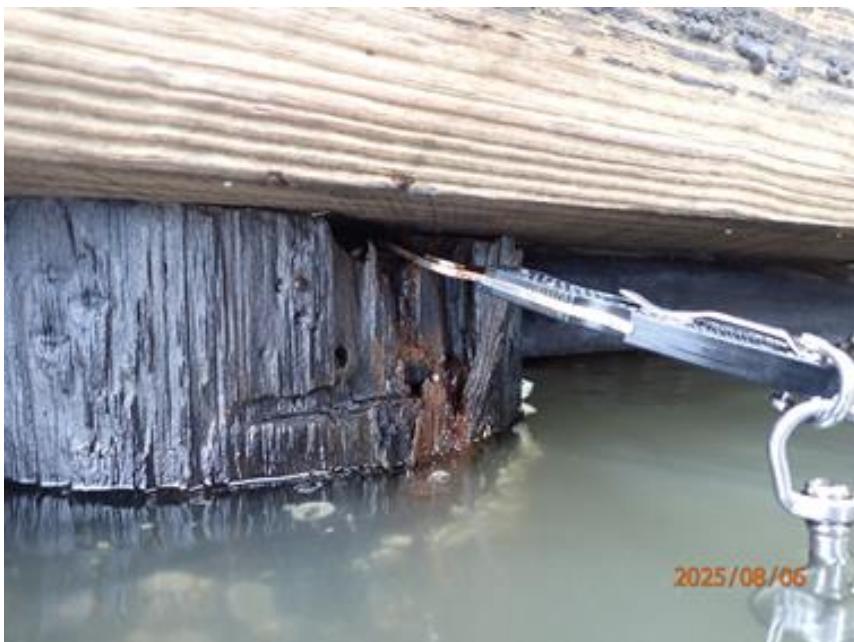
Photo 25

North Abutment: The piles exhibit a full-circumference, hollow-sounding area with surface rot starting at the cap that extends below the mud line. There are minor checks in the top of Pile 1. Pile 4 exhibits a gap/void (2 1/2" wide x 1/2" high x 2" deep) between the top of the pile and the cap due to crushing of the south edge, resulting in approximately 15% loss of bearing (Photo 25).

Gap/void between the top of Pile 4 and the cap at the South Abutment, with crushing of the pile and loss of bearing, looking north.

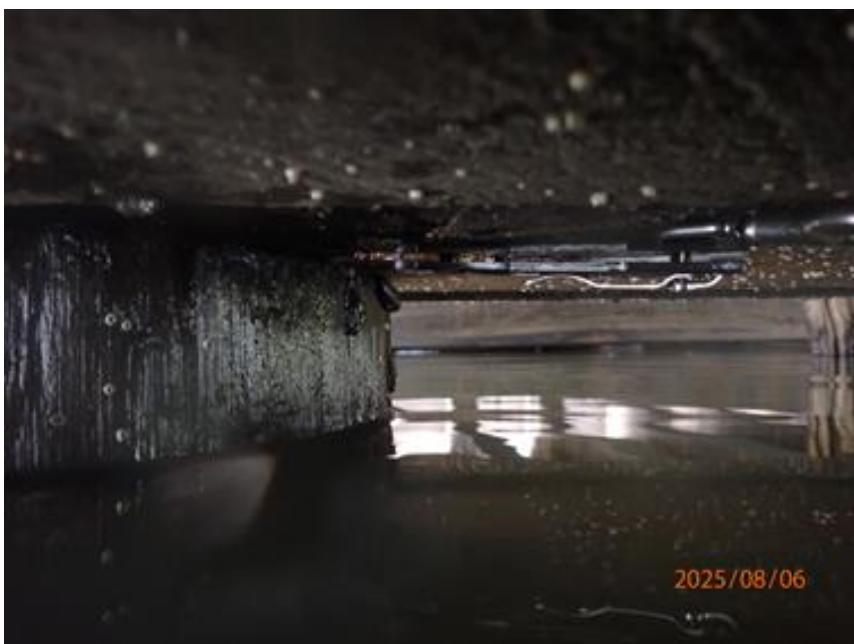
Photo 26

Gap and loss of bearing between the top of Pile 4 and Bent 1 Cap due to pile movement (west), looking north.

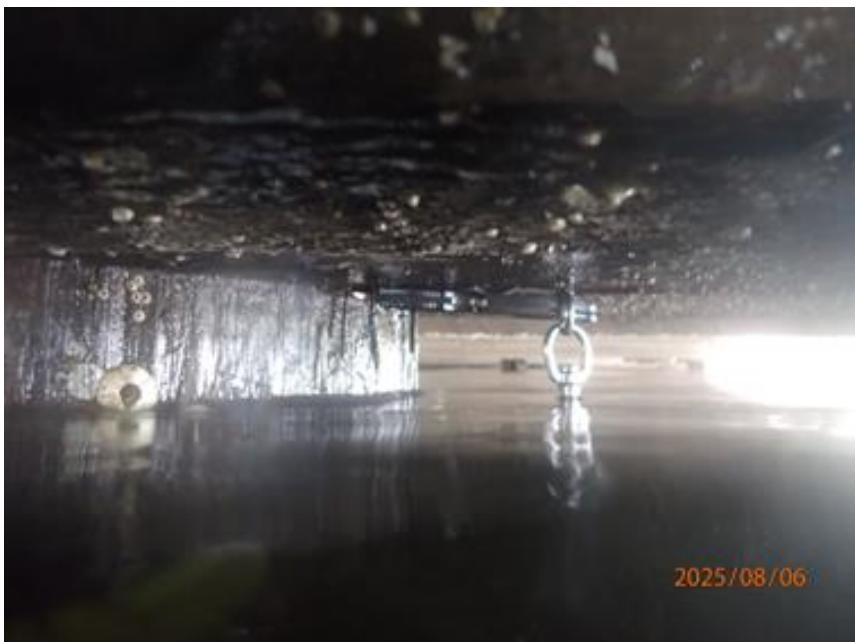
Photo 27

Gap and loss of bearing between the top of Pile 2 and Bent 2 Cap due to crushing and pile movement (west), looking north.

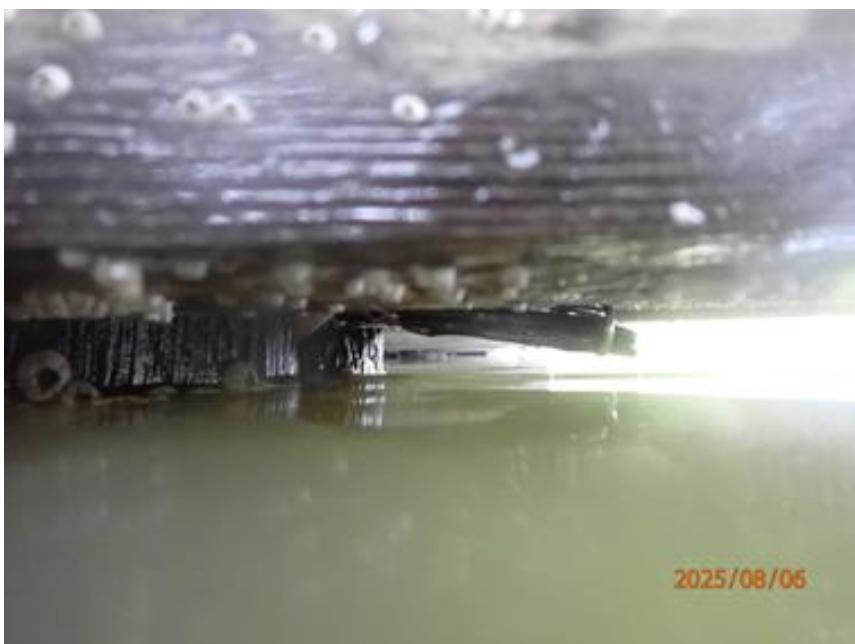
Photo 28

Area of crushing with a splinter in the top of the east face of Pile 1 at Bent 3, looking north.

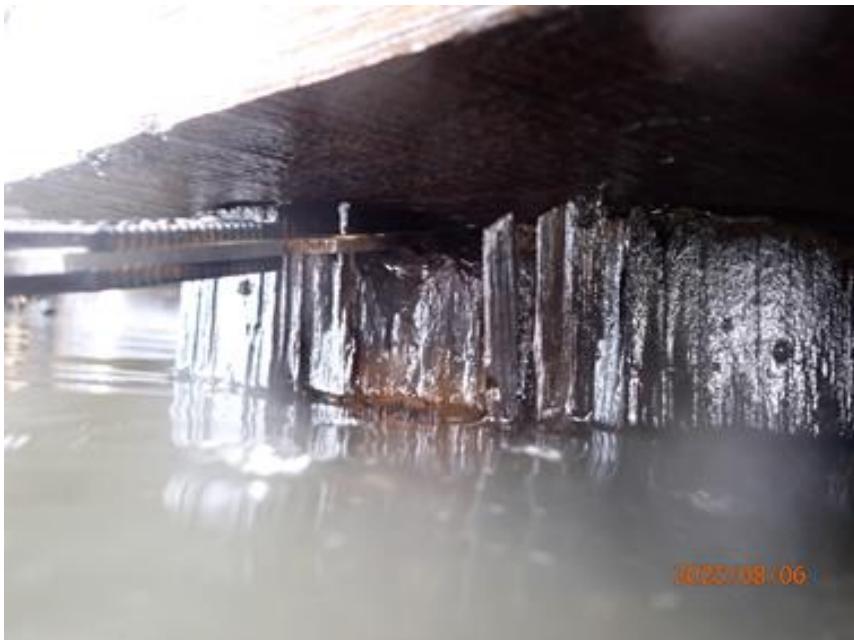
Photo 29

Area of crushing in the top of the north face of Pile 1 at the South Abutment, with loss of bearing, looking southeast.

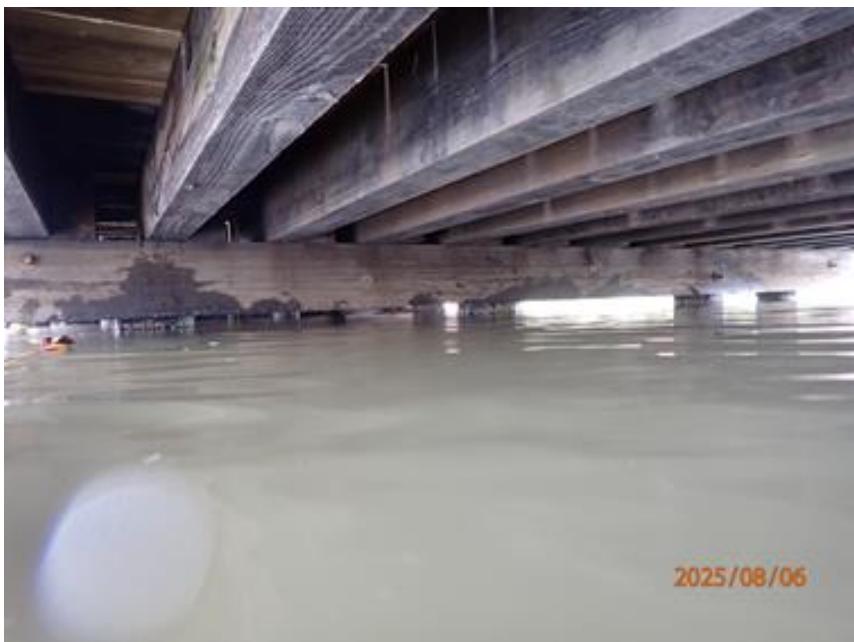
Photo 30

3. The timber bent caps (Photo 30) exhibit hollow-sounding areas with surface rot throughout with the worst deterioration at the piles. The bent caps have previously been retrofitted with sister boards on the vertical faces. There are up to 10" long x 2" wide x 1 1/2" high shakes and checks throughout with up to 2" pick penetration in the west ends of the caps. There is minor to moderate surface rust and delamination in the connection hardware.

Typical condition of the timber bent caps (Bent 2, south face shown, looking northeast).

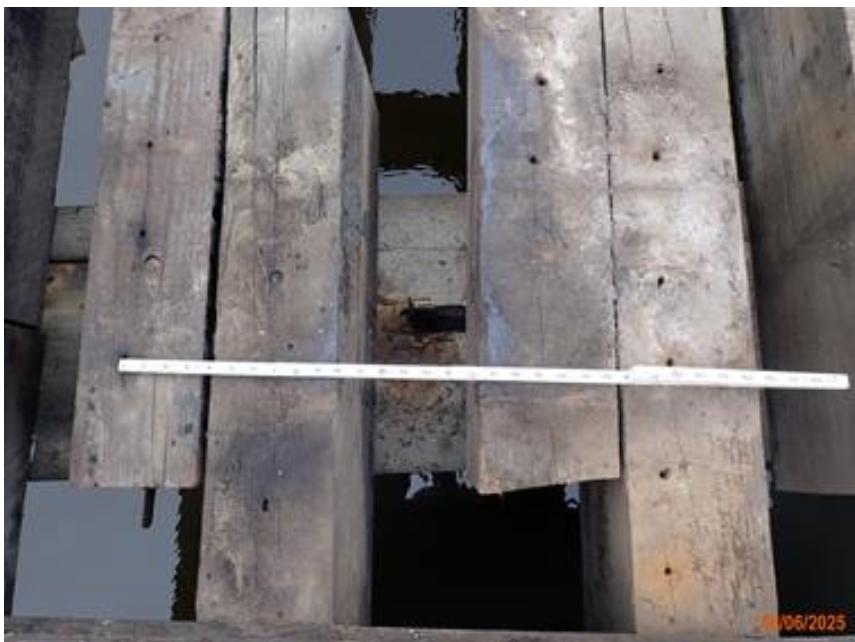
Photo 31

Severe rot with full-depth holes in the Bent 1 Cap between Beams 2 and 3, looking north.

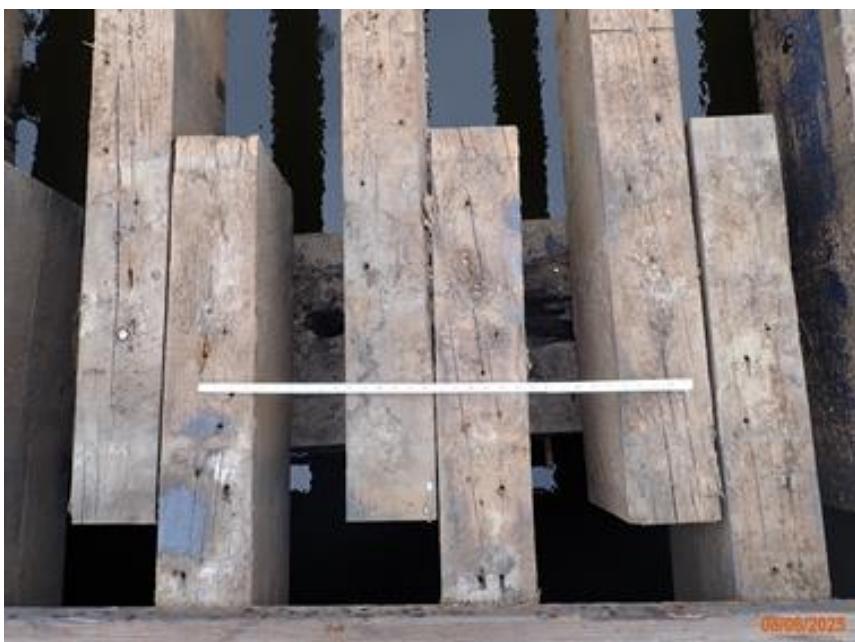
Photo 32

Severe rot with full-depth holes in the Bent 1 Cap between Beams 6 and 8, looking north.

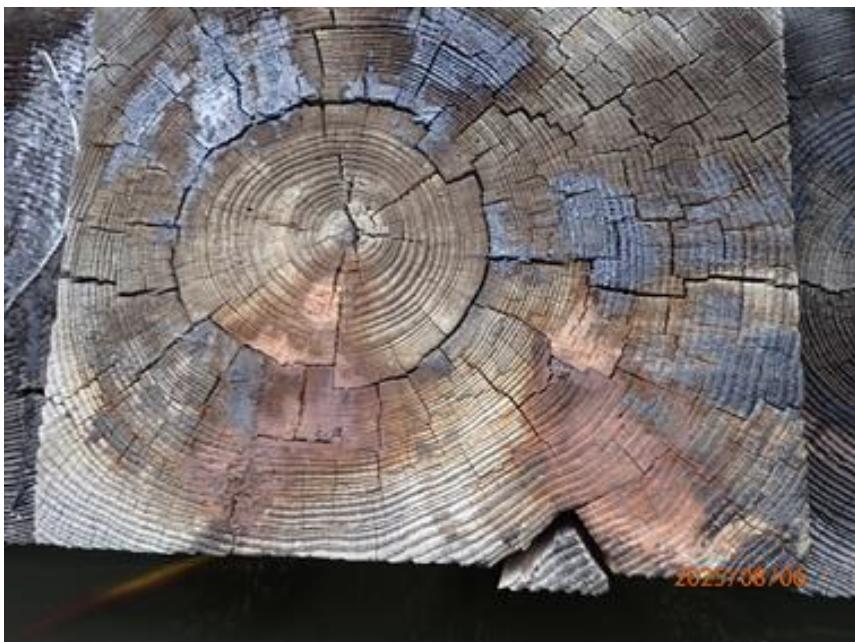
Photo 33

Bent 2: The west face of the cap exhibits rot with up to 3" deep pick penetration. The cap exhibits hollow-sounding areas (up to 2'-0" long x full-height x full-width) with surface rot at Piles 1 and 4. The cap exhibits hollow-sounding areas (up to 2'-0" long x full-height x full-width) with core rot at Pile 3. The east end of the cap exhibits a splinter (6" long x 2 1/2" wide) in the bottom edge (Photo 33).

Splinter in the east end of the bottom face of the Bent 2 Cap, looking west.

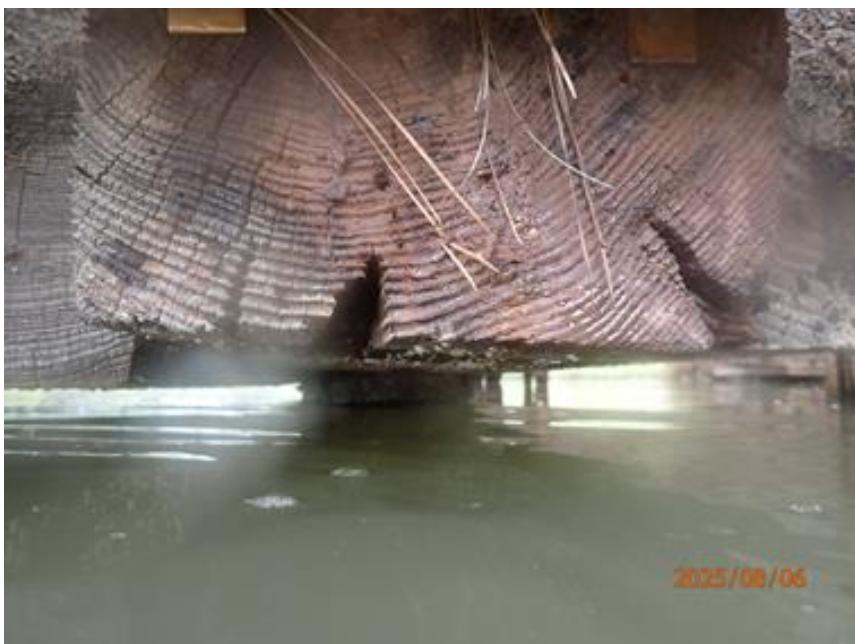
Photo 34

Bent 3: The west face of the cap exhibits an area of rot (0.5 SF) with 1/2" deep pick penetration and 3/4" wide splinters in the bottom face (Photo 34). The cap exhibits hollow-sounding areas (up to 2'-0" long x full-height x full-width) with surface rot at Piles 1 and 3.

Splinters in the west end of the bottom face of the Bent 3 Cap, looking east.

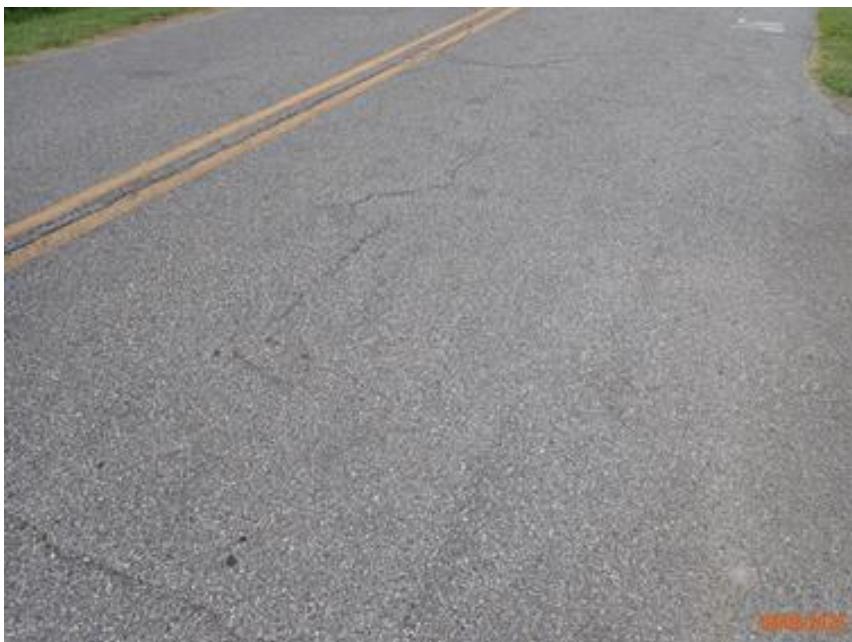
Photo 35

1. The asphalt pavement on the approaches exhibits up to 1/8" wide map cracking with edge chipping throughout (Photo 35). There is a 1/16" wide x 4'-0" long transverse crack in the North Approach Transition. There is a full-width x up to 8" long asphalt patch that is up to 1/2" higher than the deck planks at the South Approach Transition.
2. The Northeast Embankment exhibits an area of erosion (2'-0" long x 2'-6" wide x 1'-6" high) at the abutment, exposing a 10" high x 9" wide area of the back face of the backwall.

Typical map cracking in the approach roadways (North Approach shown, looking northwest).

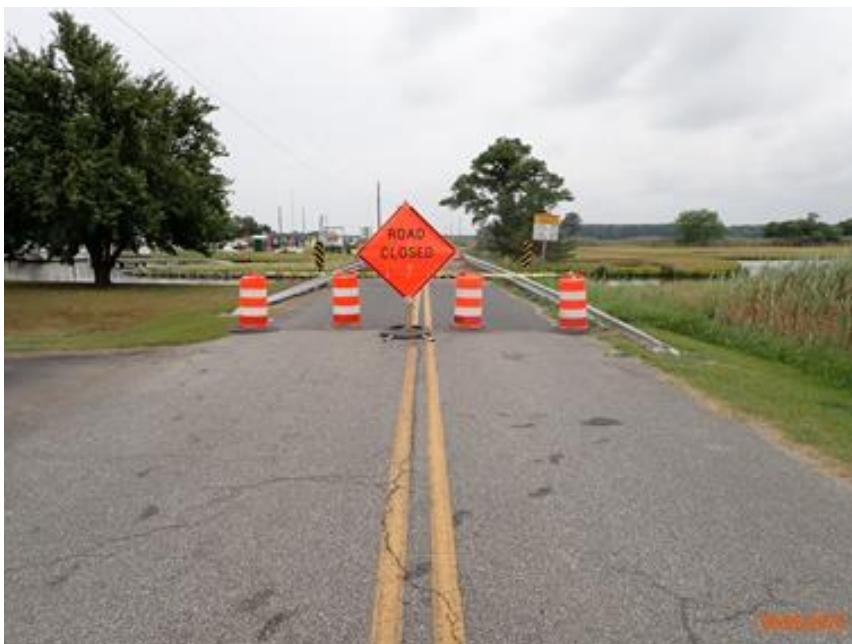
Photo 40

The bridge is currently closed to traffic for deck repairs and there are temporary "Road Closed" signs with traffic barrels on the approaches (Photo 40). There are also temporary "Road Closed Ahead" signs at the intersection with Public Landing Road on the North Approach and at the intersection with Stagg Road on the South Approach. Temporary detour signs are in place along the detour route.

Road Closed sign and traffic barrels on the North Approach, looking south.

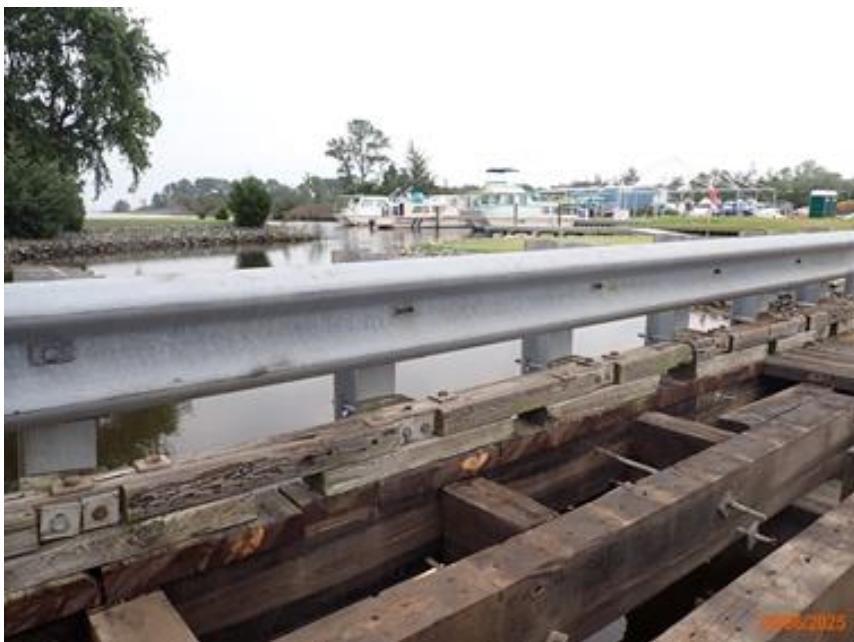
Photo 41

Typical removed post to W-beam connection bolts (East Railing, Posts 3 through 6 shown, looking southeast).

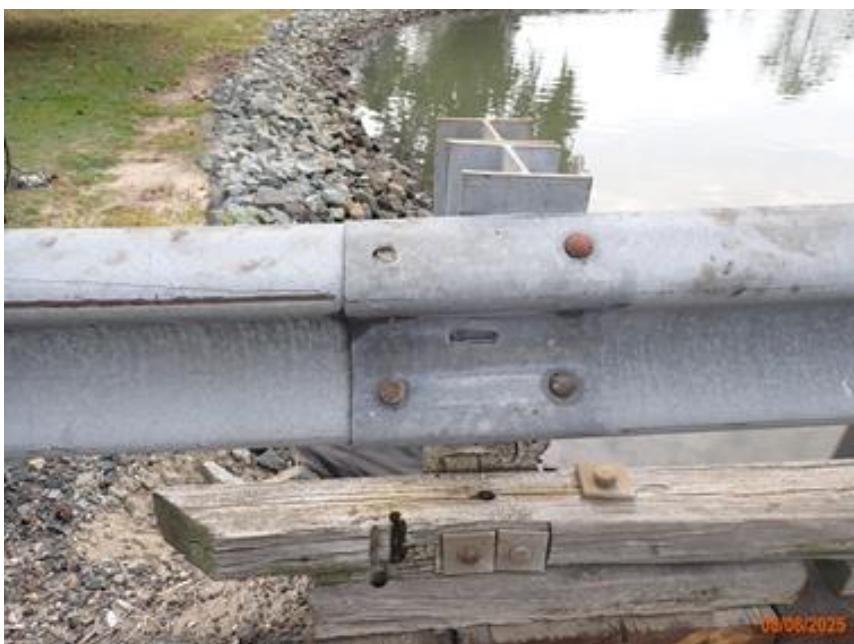
Photo 42

Missing and loose splice bolts and post connection bolt at Post 1 along the East Railing, looking east.

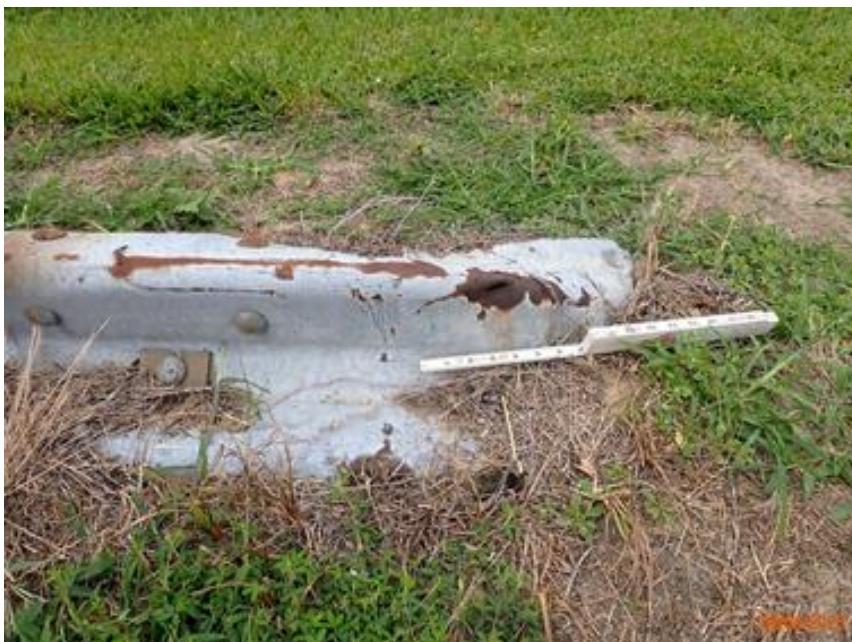
Photo 43

Tear due to impact damage in the Northwest Traffic Barrier end treatment, looking west.

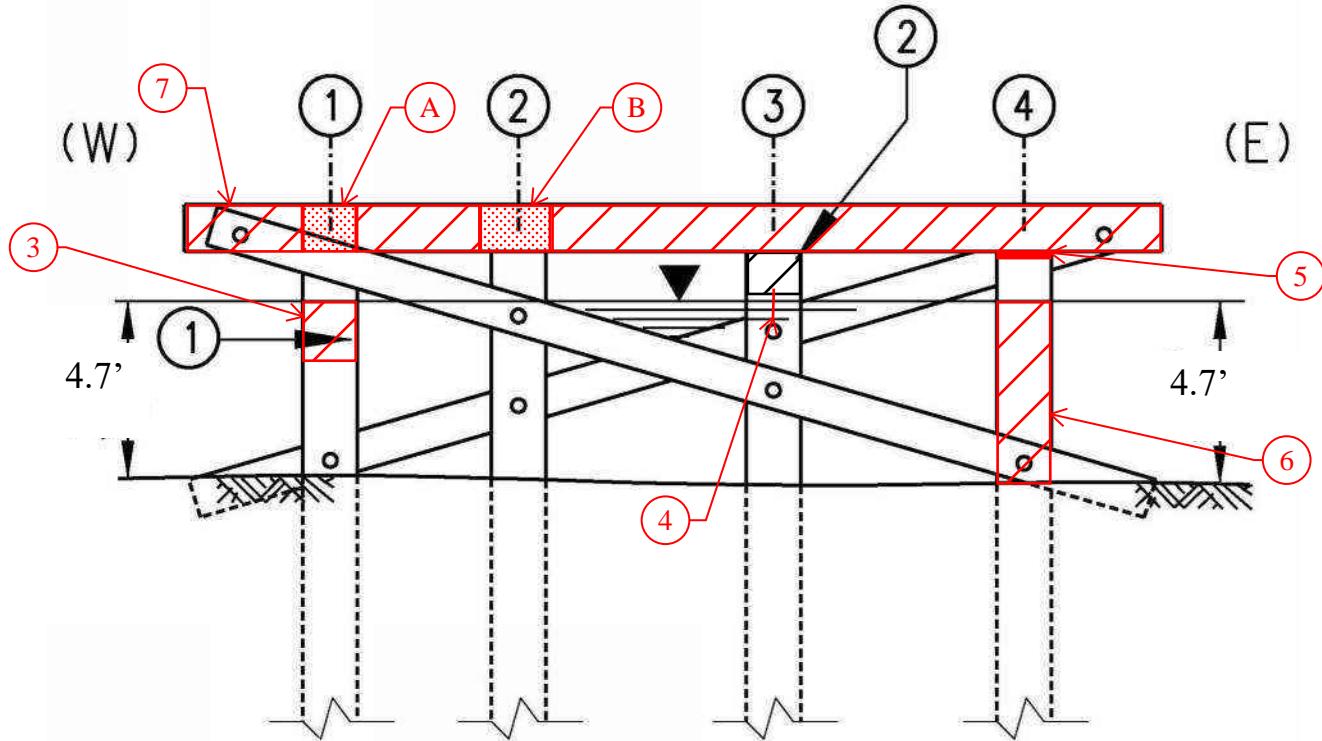
BENT 1
SOUTH ELEVATION
 (N.T.S.)

- (A) Area of severe rot (1'-0" long x up to full-width x full-depth) with a full-depth hole in the top face of the cap between Beams 2 and 3, adjacent to Pile 1.

- (B) Area of severe rot (3'-0" long x up to full-width x full-depth) with full-depth holes in the top face of the cap between Beams 6 and 8, at Pile 2.

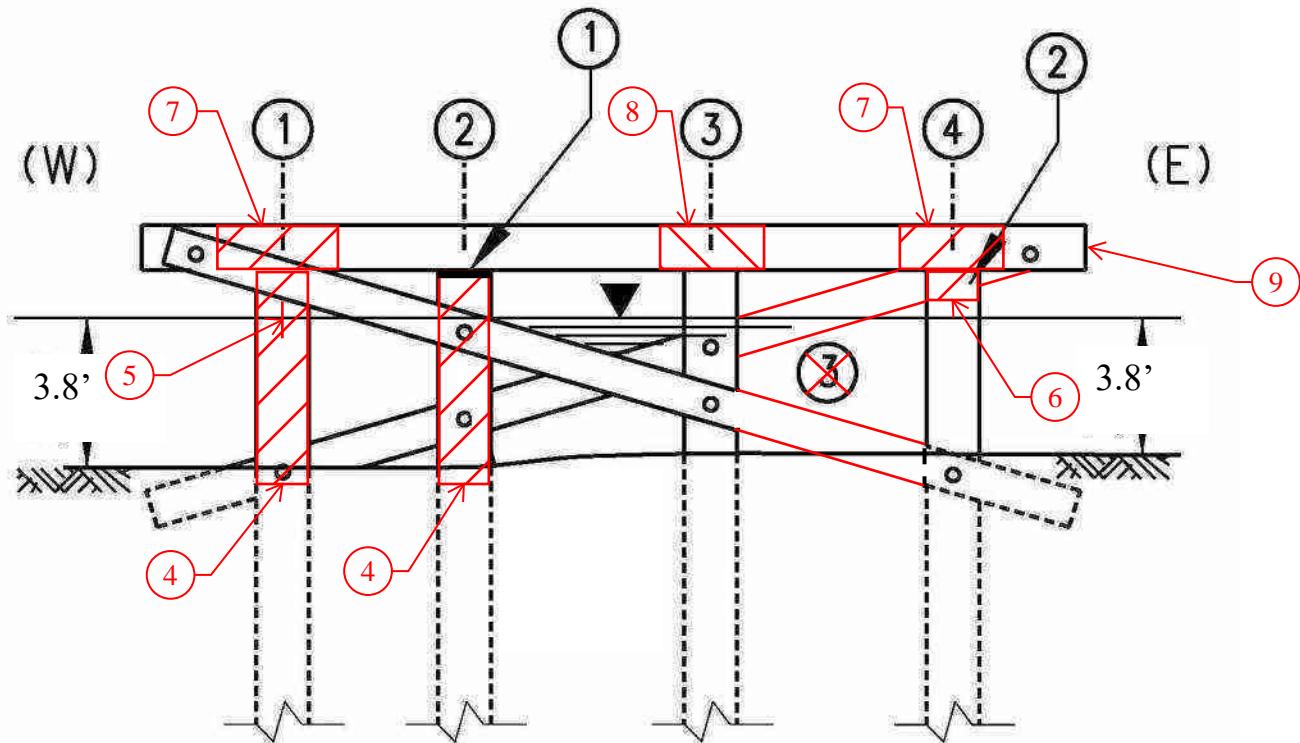
BENT 2
SOUTH ELEVATION
 (N.T.S.)

- ① The bottom of the pile cap at Pile 2 has a 10" long x 3" wide x 1" deep void (~30% loss of bearing).
- ② The East Face has a 3/8" wide x 3" high x 1" deep check at the top.
- ③ There is no cross-bracing between Piles 3 and 4 (Not observed).
- ④ Full-circumference hollow-sounding area in Piles 1 and 2 starting at the cap and extending below the mud line.
- ⑤ Check (1" high x 2 1/2" deep x 1/8" wide) in the south face of Pile 1 at the waterline.
- ⑥ Full-circumference hollow-sounding area (6" high x full-width) with surface rot in the top of Pile 4.
- ⑦ Hollow-sounding area (full-height x full-width) with surface rot in the cap at Piles 1 and 4.
- ⑧ Hollow-sounding area (full-height x full-width) with core rot in the cap at Pile 3.
- ⑨ Splinter (6" long x 2 1/2" wide) in the bottom of the east face of the cap.
