2025 ANNUAL AND UNDERWATER BRIDGE INSPECTION REPORT

August 6, 2025

BRIDGE NO. WO0202001
BAYSIDE ROAD
OVER
TANHOUSE CREEK

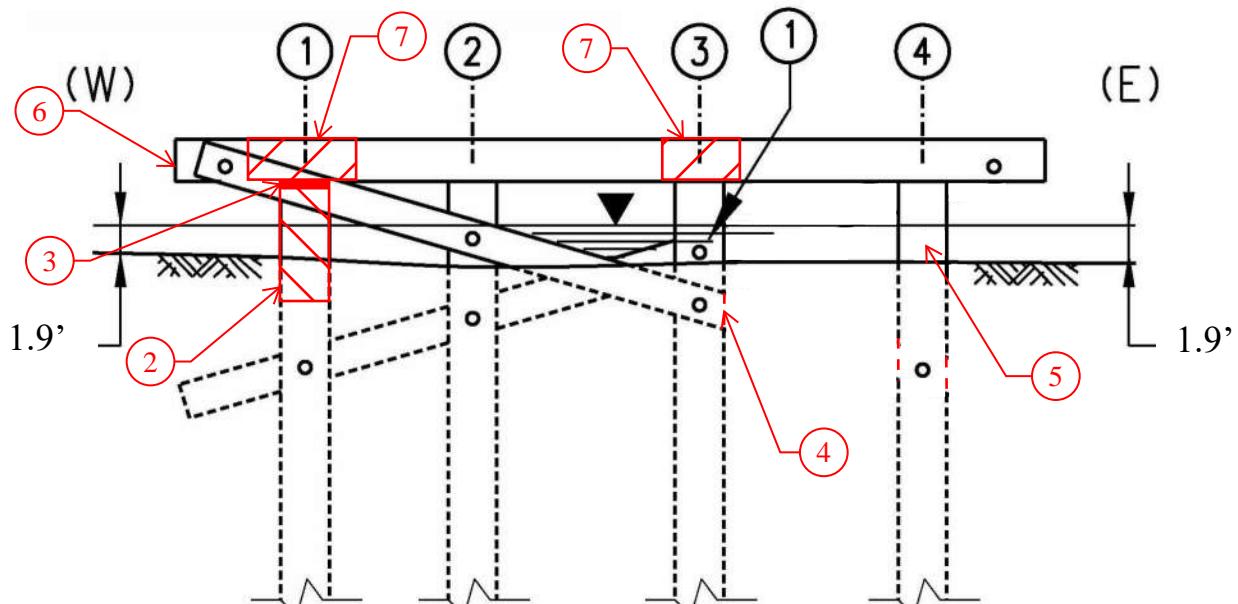
BENT 3
SOUTH ELEVATION
 (N.T.S.)

- ① The hardware on the crossbracing has severe corrosion with up to 30% section loss.
- ② Full-circumference hollow-sounding area with core rot in Pile 1 starting at the cap and extending below the mud line.
- ③ Area of crushing in the top of the east face of Pile 1 with 3" deep pick penetration and a splinter (3" high x 1/8" deep) extending down from the cap.
- ④ The cross-bracing has been removed between Piles 3 and 4.
- ⑤ Minor surface rot throughout Pile 4.
- ⑥ Area of rot (0.5 SF) with 1/2" deep pick penetration and 3/4" wide splinters in the west face of the cap.
- ⑦ Hollow-sounding area (full-height x full-width) with surface rot in the cap at Piles 1 and 3.
