## **Addendum # 1 Housing Rehabilitation – Berlin #4 REBID**

**Berlin # 4 – November 28, 2022**

# DEBRA W HALL INSPECTIONS, INC

RE: 10319 Germantown Rd, Berlin, MD

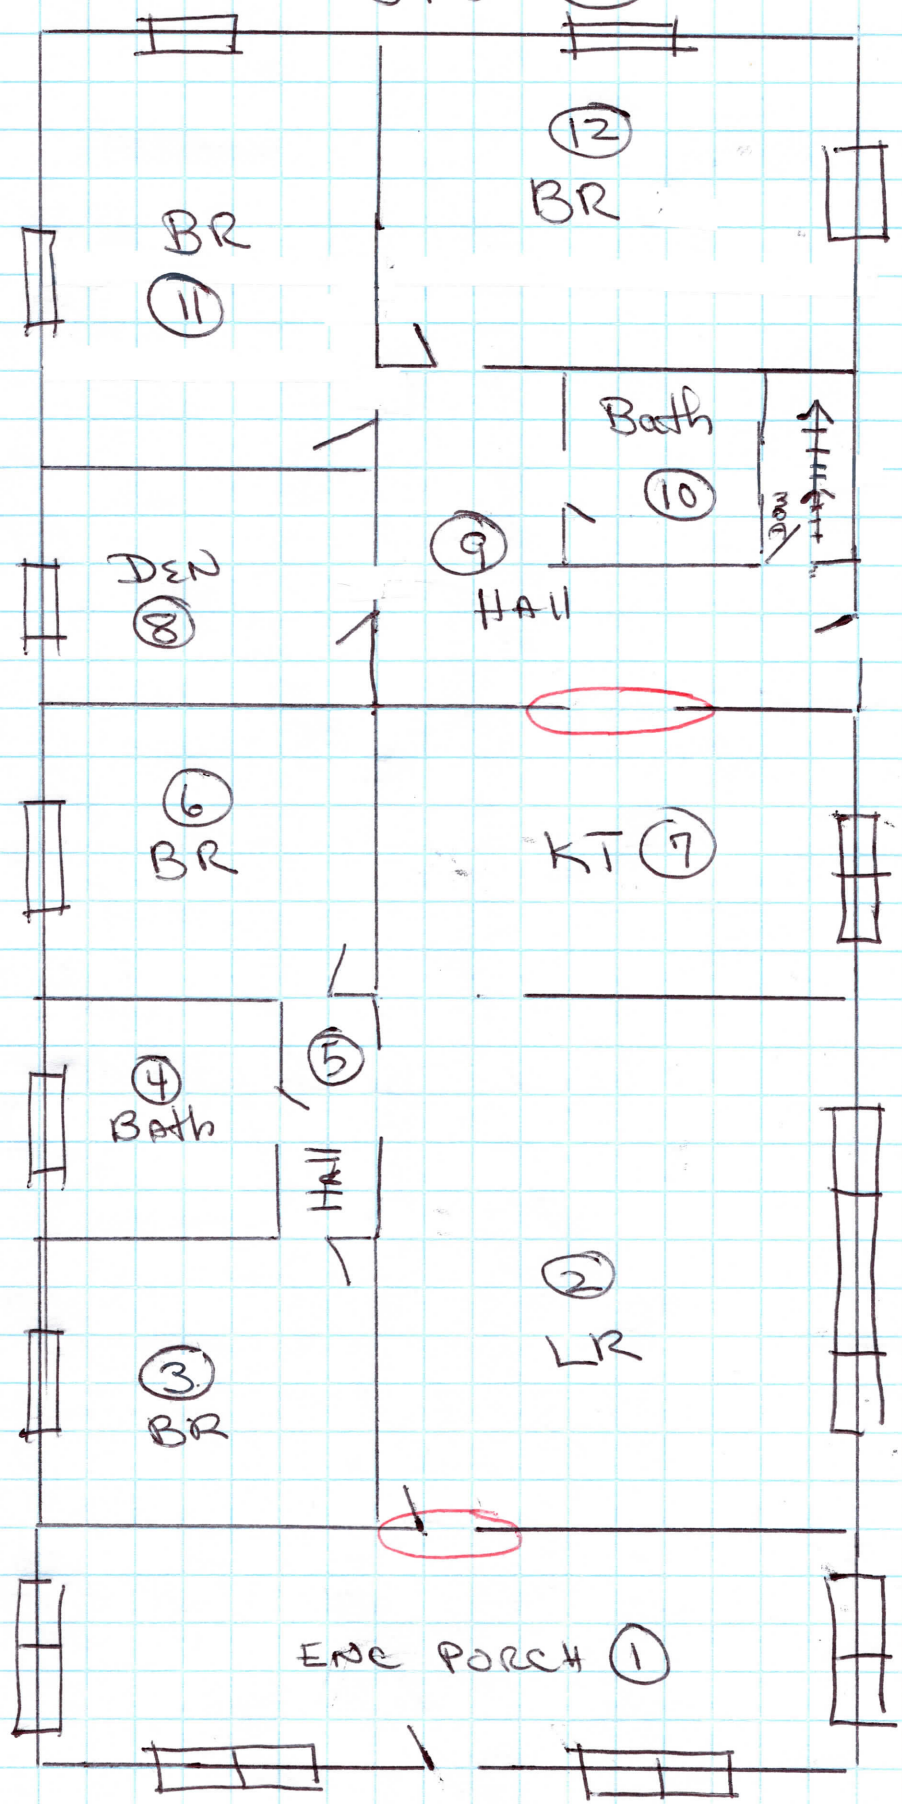
← 10319 Germantown Rd, Berlin →

Sun Porch (#1)	Door Casing & Jamb	Side C	white	Positive
Living Room (#2)	Door Casing & Jamb	Side A	white	Positive
Kitchen (#7)	Door Casing & Jamb	Side C	white	Positive
Hall (#9)	Door Casing & Jamb	Side A	white	Positive

The home was built in 1958. The original exterior front porch was enclosed into a room. The ceiling is the original ceiling and is positive for lead based paint. The door way between the enclosed porch and the living room was the original exterior door entrance. The door has been replaced and is negative for lead based paint; however, the jambs, and casings on in both rooms are positive for lead based paint. An addition was added onto the rear of the home. The door way between the kitchen and the hall is the same scenario as the doorway between the living room and porch. The jambs and casings in both rooms are positive for lead based paint. There is no door between the kitchen and hall.

- a) ABATEMENT - RECOMMENDED: Remove and replace jambs and casings with new components. Plane and rehang door.

a) INTERIM CONTROLS - STABILIZATION: Following preparation work, the lead-based paint coatings may be addressed by stabilizing the underlying substrate and then repainting.

a) ABATEMENT - RECOMMENDED - Enclose the ceiling behind a hard rigid barrier that is mechanically fastened to the ceiling and sealed to prevent dust from escaping. i.e. drywall, wood, or vinyl.
